# Revista Brasileira de Geografia Física

## Environmental Quality of the Monapo River Basin in Mozambique - A Report of Experience

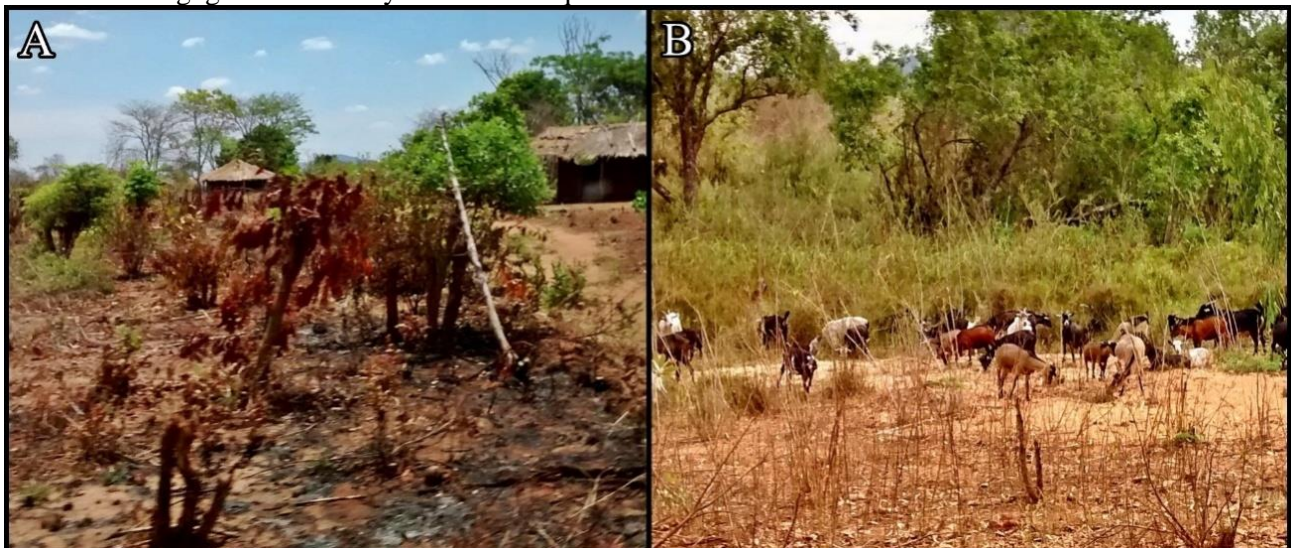
Collection point 1 is closest to the source of the Monapo river. It has, for the most part, sparse vegetation, very sandy soil, with human occupation including subsistence farming houses and activities such as goat breeding, as well as sugar cane and cassava planting. The collection of mango and cashew is also a common activity in this area. Some of the physical characteristics of the region near the source can be observed in Figure 3 A-B.

Figure 3. A - Presence of houses, vegetation and burnings; B - Presence of animals on sandy soil with scarce pasture. Source: Authors' production (2018).

The areas with burn can be seen in Figure 3. These were carried out by the local residents because there was no other way to dispose of garbage, and also due to the need to use the forest areas for goat farming.

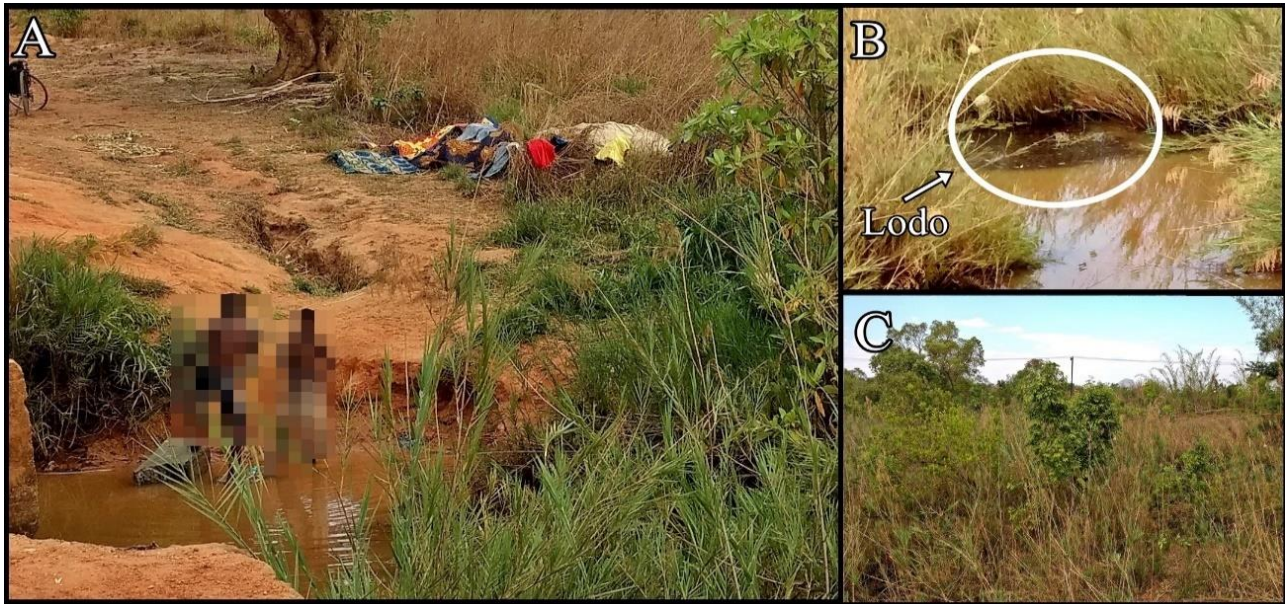
The second point of analysis is located approximately 22 km from the source, where water pools were verified, but without current. As shown in Figure 4, the site contains exposed soil (Figure 4 - A), providing high water turbidity, with presence of sludge (Figure 4 - B). The vegetation of the banks is composed of forage plants and small trees typical of the savanna domain (Figure 4 - C).

Figure 4. Physical characteristics of point 02 analyzed. Source: Authors' production (2018).

The population of the region uses these waters for domestic purposes, recreation and animal watering. Some residents reported that in about eight months, the Monapo River has no water current, and it is necessary to use potable water for cooking and drinking. The largest volumes of water are recorded between the months of December and March.

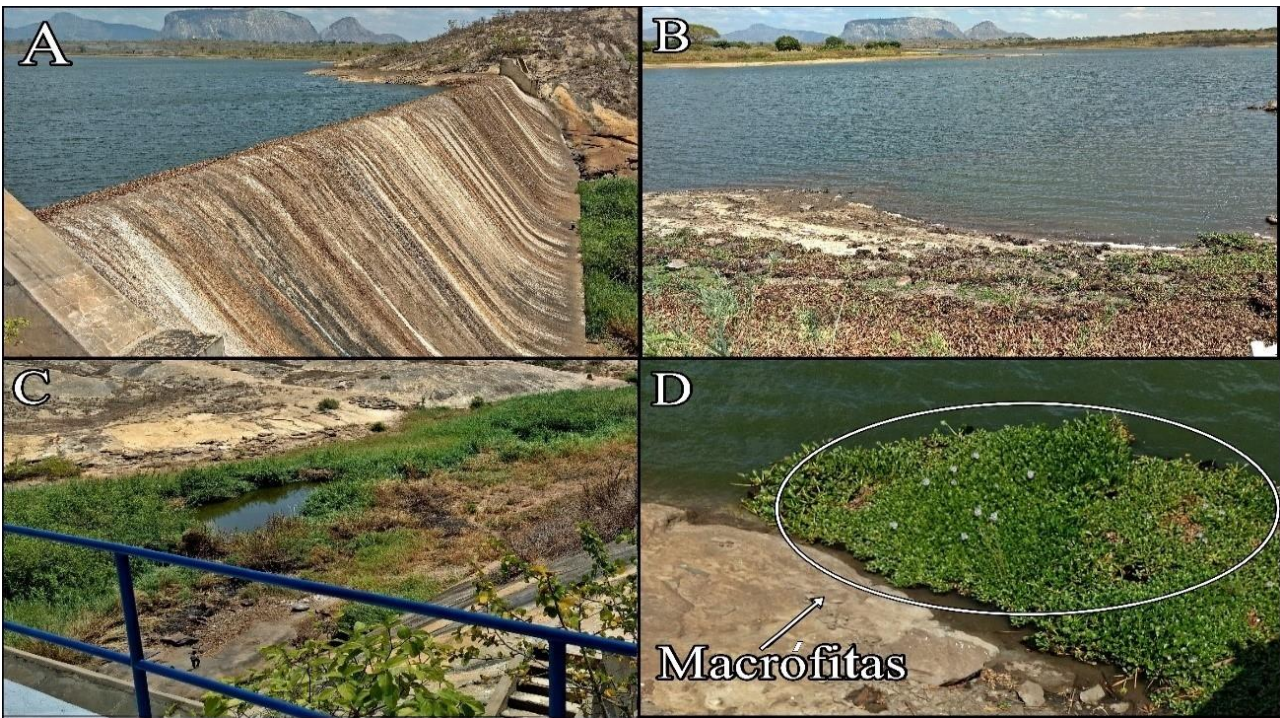
On the day of the visit, the reservoir was below the level of the bus (Figure 5 - A and B), since it was used in water mode because the water reservoir has smaller dimensions. Some characteristics of the water body can be seen in Figure 5 - C, showing the small width and quantity of water in the Monapo river, as well as the geological structure of the rocks, constituted by granite outcrops, representing the highest points and with greater slopes of the basin.

The presence of aquatic macrophytes occurred (Figure 5 - D), a feature that may indicate eutrophication or increase of nutrient loads to the reservoir, resulting from domestic sewage, and agricultural products used in small plantations near the reservoir (Conselho de Ministros, 2007).

Figure 5. Characteristics of the Monapo river reservoir in Nampula district. Source: Authors' production (2018).

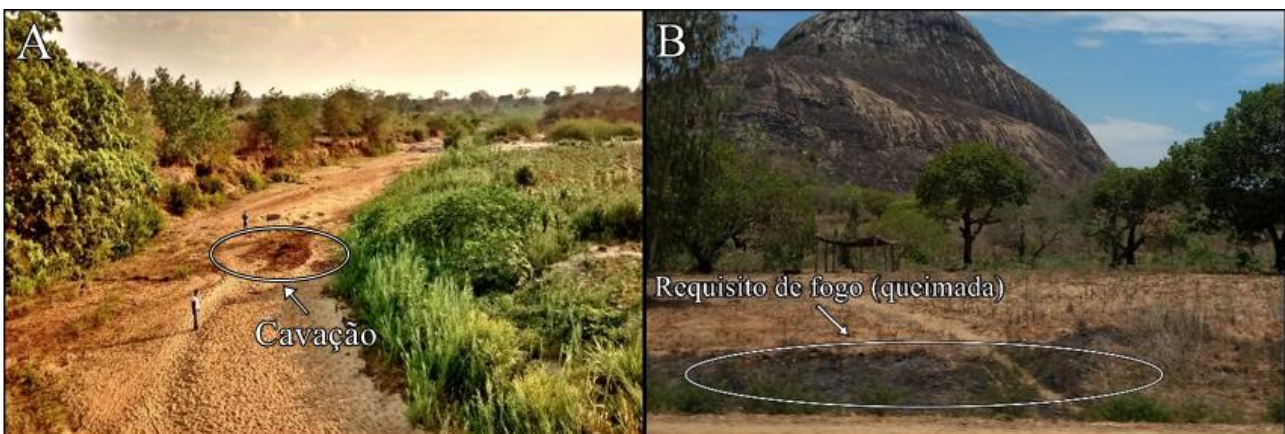
The presence of people with digging activities, markings of animals in the river bed and visible erosions of the slopes (Figure 6 - A), are indicative of the increase of sediments to the water body, providing siltation and alteration of the natural properties of the aquatic environment.

In this section of the Monapo river, the anthropic activities are present in the vicinity of its banks, by the inhabitants of the district of Muecate. Figure 6 - B shows burn marks and straw ranch in the deforested area. In the background, an outcrop of granite is observed, which together with the gneisses represent the geological base of the region, which confers a low potential for water storage in the drainage network of the basin. The relief is predominantly flat in areas near the watercourse and steep on the slopes.

Figure 6. Physical characteristics of point 04 analyzed. Source: Authors' production (2018).

As shown in Figure 6 - A, this stretch of river water has no current, being approximately 102 kilometers from the source. It is possible to

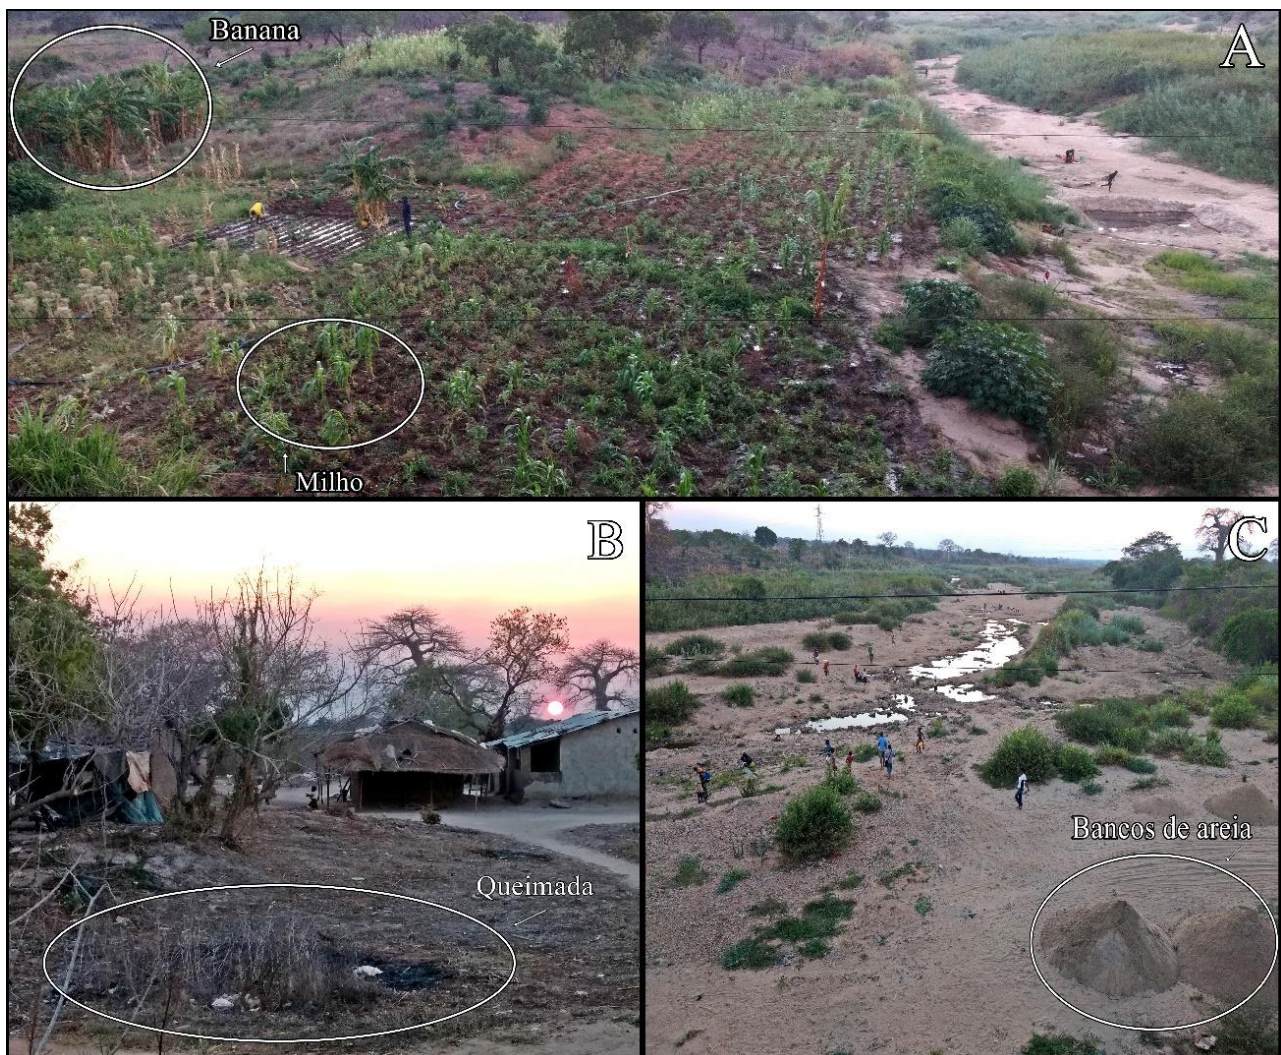
7 - B). The locals usually set fire to any set of garbage, causing burning residues, which when leached from the rainwater, are taken to the bottom of the valley.

This section of Monapo River has no current, only water which the inhabitants of the region use for domestic activities. The residents reported that they use sand from the river bed to build houses, for this they make sand banks as shown in Figure 7 - C.

Figure 7. Agricultural systems, and characteristics of the use and occupation of lands close to point 7 analyzed. Source: Authors' production (2018).

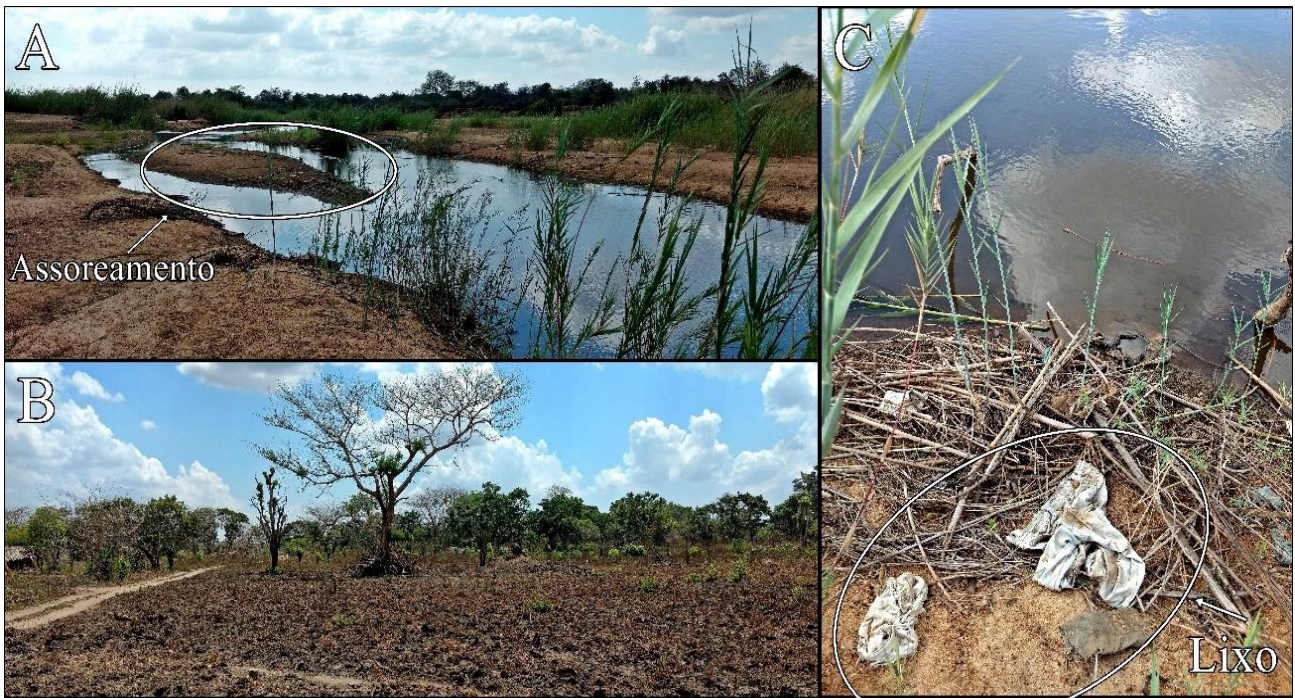
Point 06 is located below the confluence of the Monapo River with the Ampoense River (Figure 2). The characteristics of this stretch have the presence of sandy soil, lack of riparian forest due to the strong practice of deforestation, riverbank erosion, litter on the slopes and bed sedimentation (Figure 8A - B - C), making the natural habitat severely modified, significantly degrading the environment. The final result of the

Figure 8. Physical characteristics and anthropic desires (garbage) of point 06. Source: Authors' production (2018).

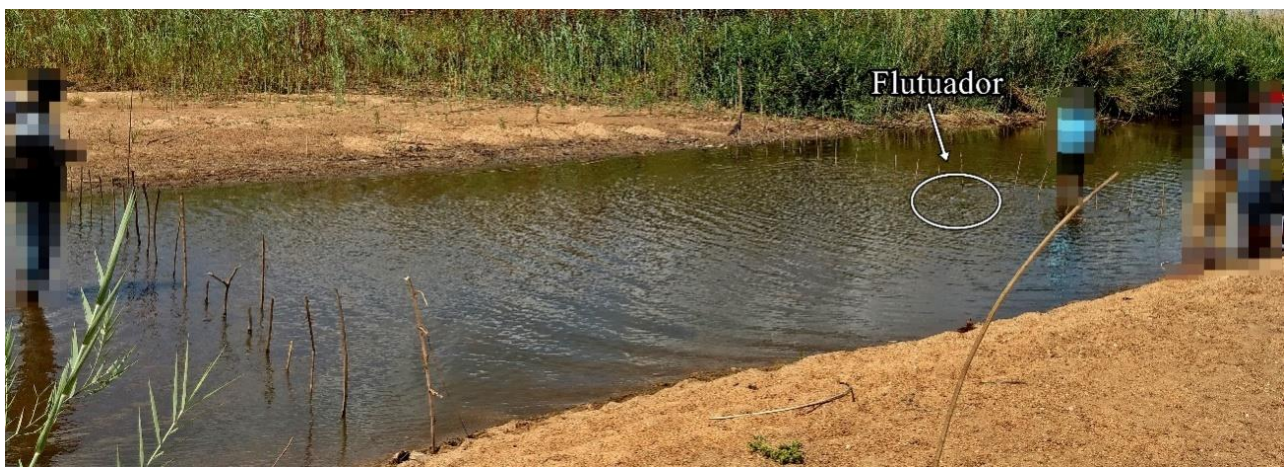
The result of the flow in the period evaluated in point 6 was 0.172 liters per second ( $m^3/s$ ). The place chosen to collect the necessary

information for the calculation was straight. Some characteristics of the bed and materials used to perform the flow can be seen in Figure 9.

Figure 9. Application of the methodology for the calculation of the flow in point 06. Source: Authors' production (2018).

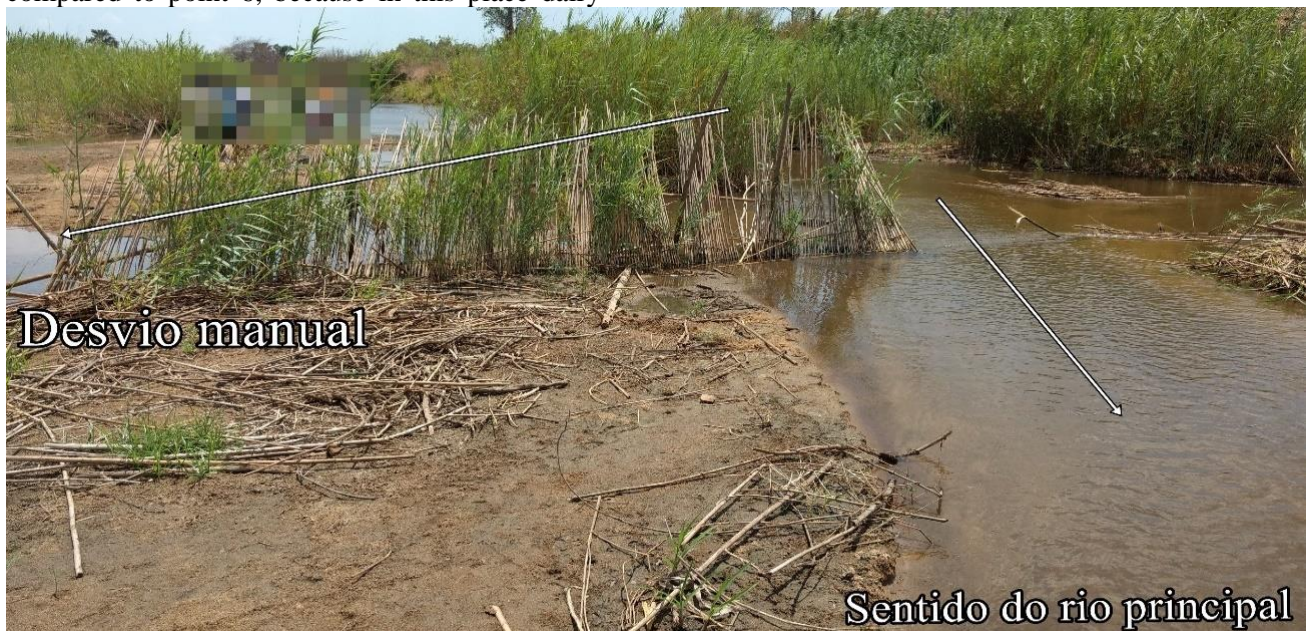
The result for the calculation of the flow of this section was  $0.52 \text{ m}^3/\text{s}$  lower than the previous stretch upstream of the Monapo river, totaling  $0.120 \text{ m}^3/\text{s}$ . This can be explained by the manual deviations made by the riverside population, upstream of point 7, since the inhabitants of the region rely only on these waters for domestic activities. Part of this characteristic has been recorded in Figure 10.

Figure 10. Manual deviation of the Monapo river, upstream of point 7 analyzed. Source: Authors' production (2018).

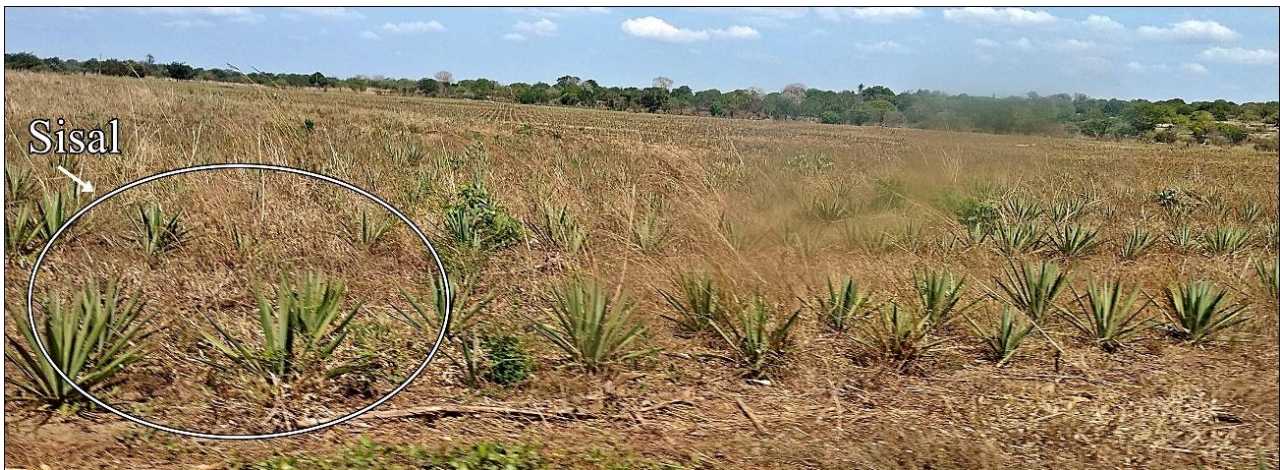
The anthropic activities of this region are strongly indicative of the alteration of these habitats, directly compromising the environmental quality. The vegetation cover is composed of small numbers of forage plants, distant from the water body, with no presence of riparian forest on the slopes of the bed, in some regions with sisal plantations (Figure 11).

Figure 11. Sisal plantation near the water body. Source: Authors' production (2018).

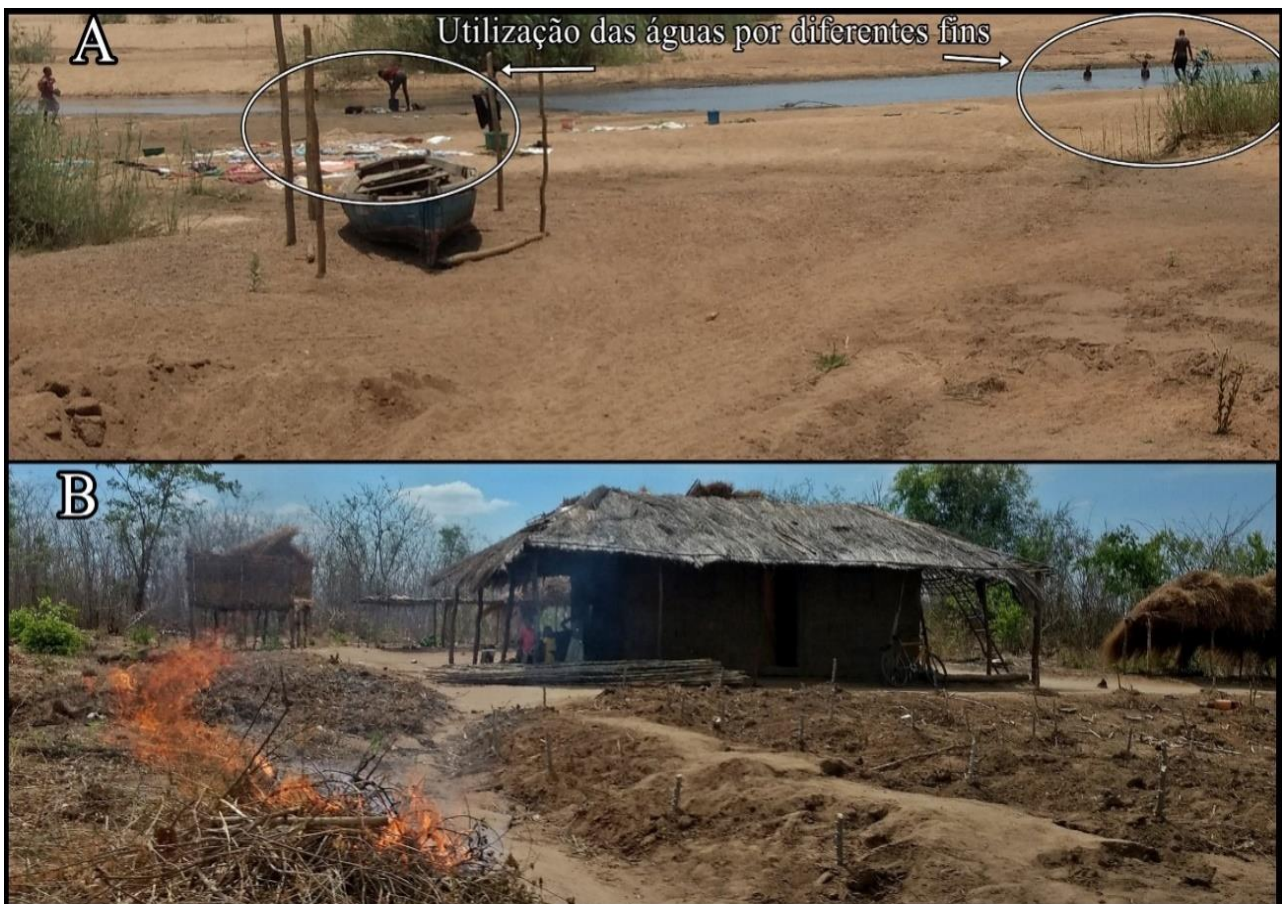
market, and part of it is used by factories in the region, offering income and a better quality of life for workers. This study noted the practice of burning near riverside houses, and domestic activity, such as washing clothes in the water body (Figure 12 A-B).

Figure 12. Physical characteristics and domestic activities in the Monapo river. Source: Authors' production (2018).
