# Revista Brasileira de Geografia Física

## Emergency repairs downstream of earth and rockfill dams with water spring with indication of internal erosion

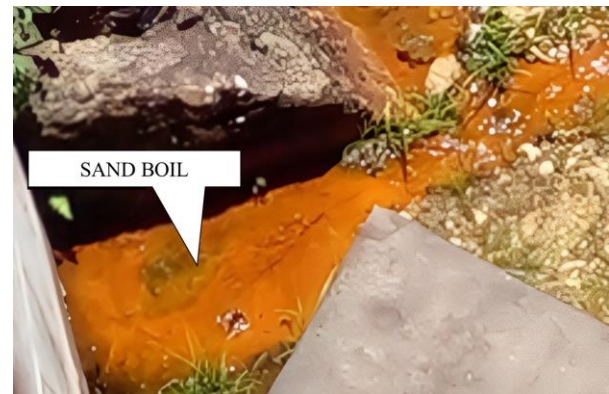
Next, in Figure 4, we observe the transport of material with water coloration indicating suspended particles.

Figure 4. Transport of Suspended Material [adapted from Interterchne] (2022).

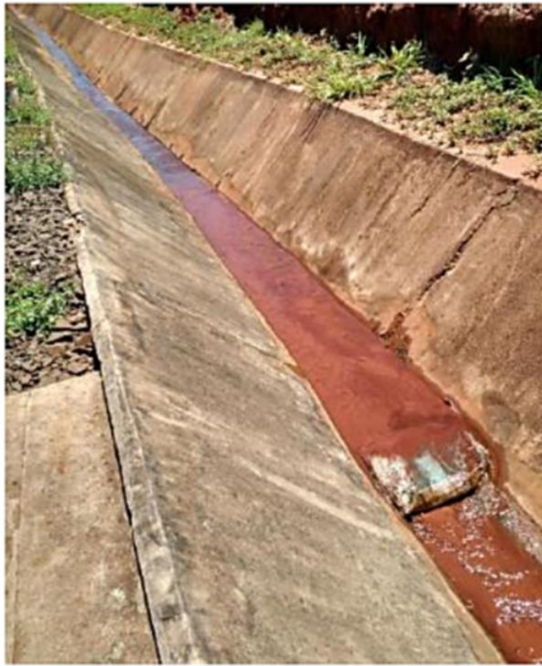
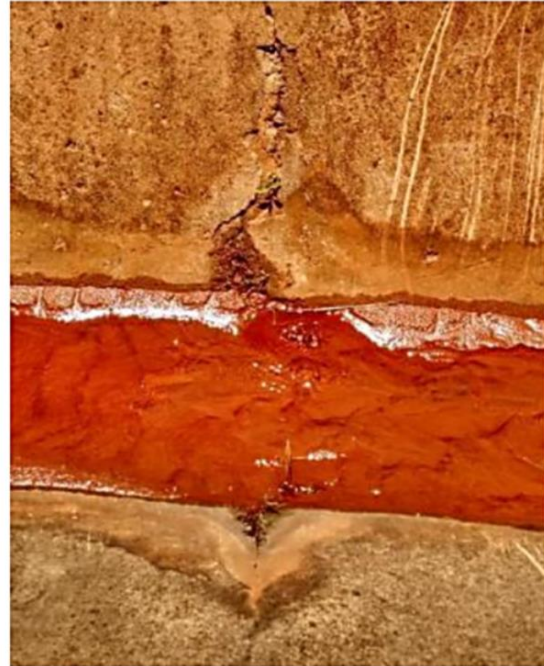
FIGURE 7 presents photograph of accumulation of solid material transported with reddish coloration as well as some seepages coming from lateral walls of trapezoidal channel located downstream from a dam.

Figure 7. Transport of Solid Material [Intertechne] (2022).

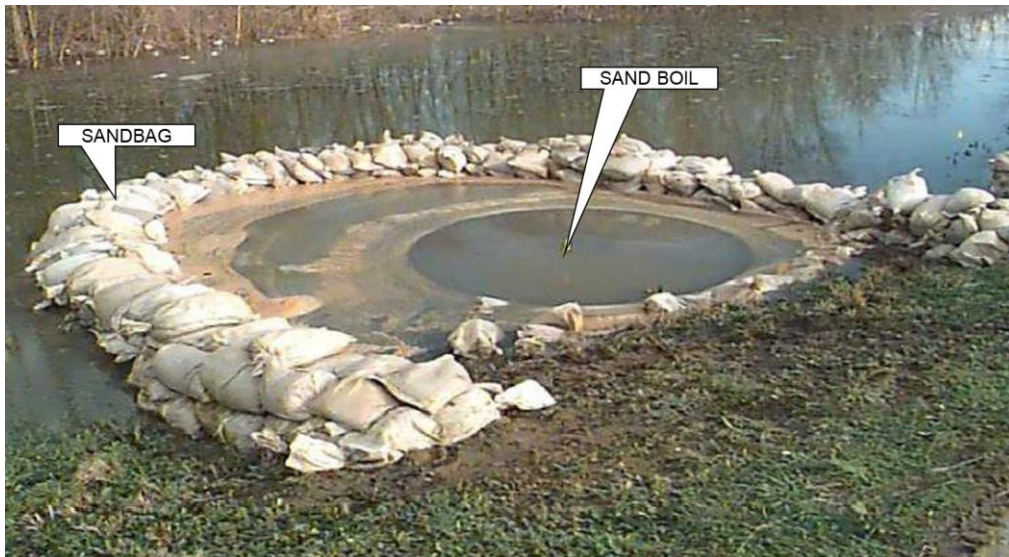
As an emergency and temporary intervention, it is recommended to construct a sandbag intercept dike to direct the water to a single point, then impound the water within this enclosure, forming a larger water body above the water emergence point, reducing the likelihood of erosion (piping), thus preventing an increase in the hydraulic gradient (FEMA, 2015).

Figure 10. Sandbag Intercept Dike [FEMA] (2015).
